TAHQUITZ CREEK

Levee ID 16 Provisionally Accredited Levee Analysis

AUGUST 2009

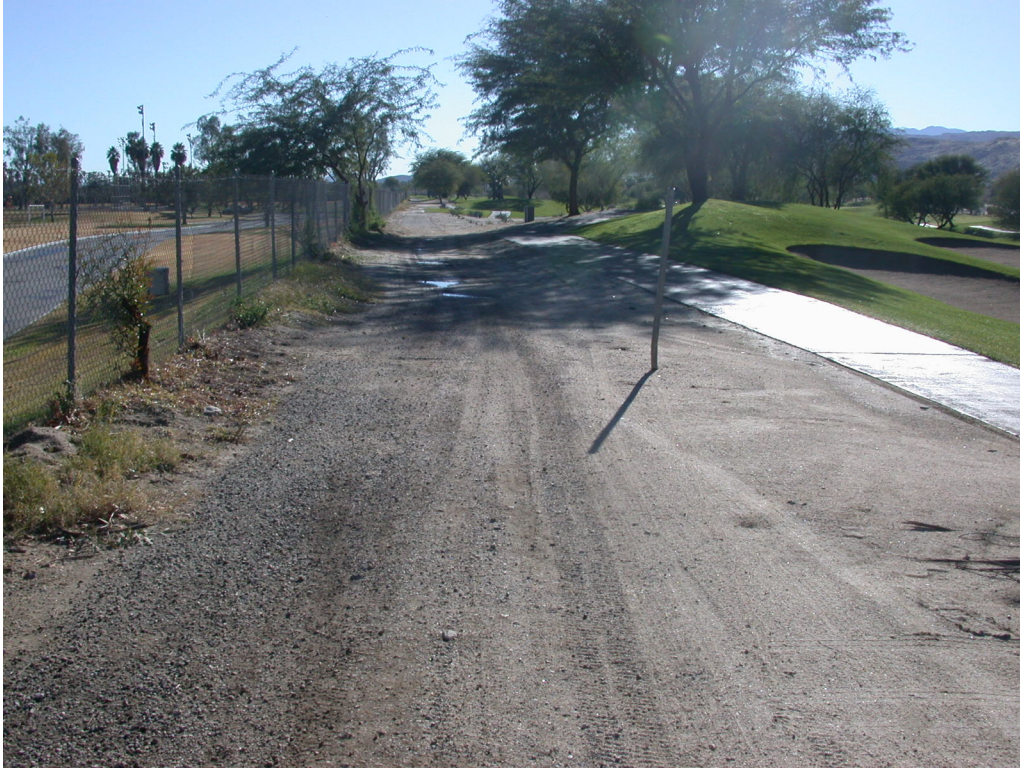
Upstream end of levee at Station 0+00; looking downstream. Tahquitz Channel to the right.

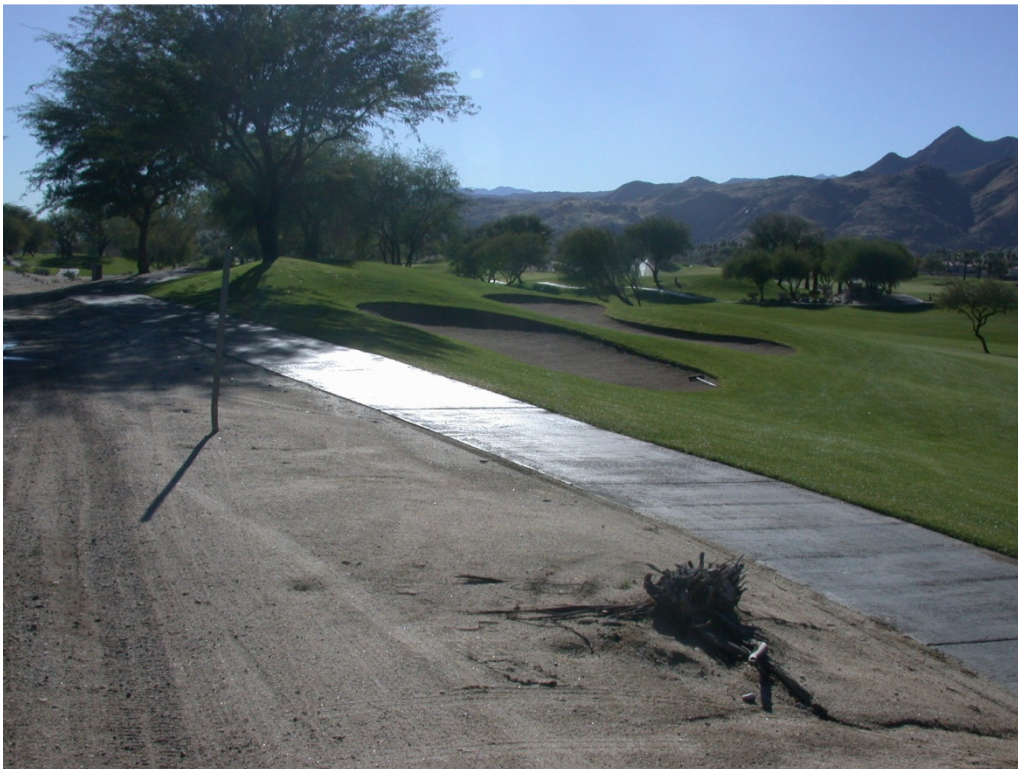
From top of levee near Station 0+00, looking at Tahquitz Creek. Note: the channel is higher than top of levee.

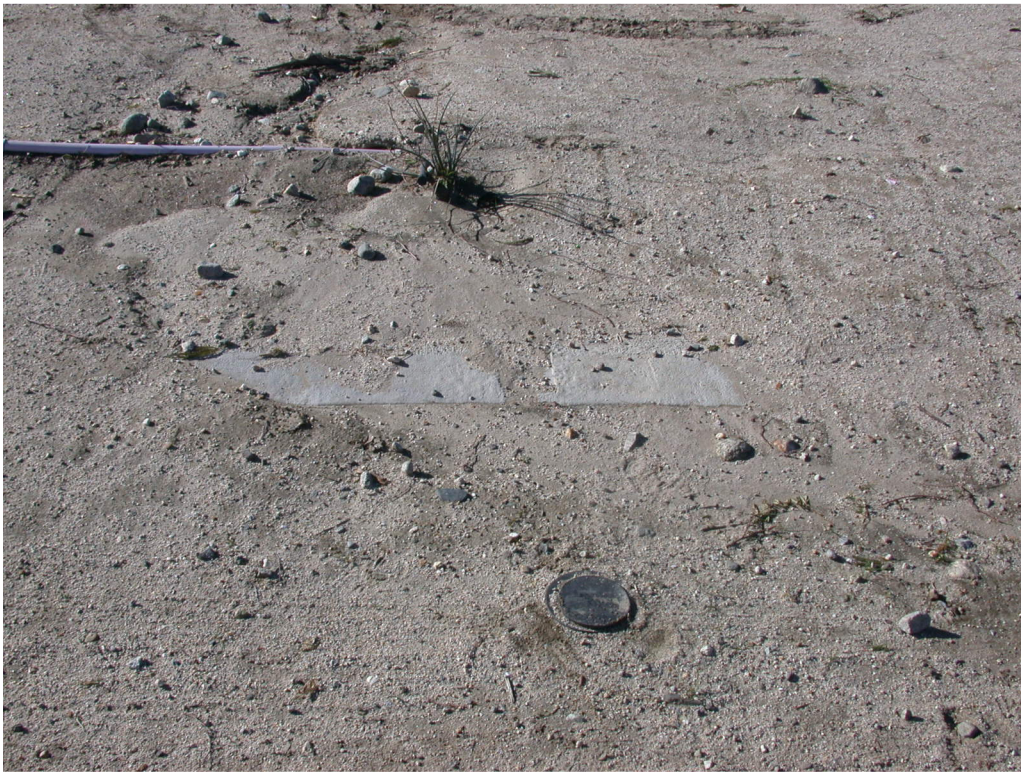
The levee appeared to be well maintained with minimal animal burrows and erosion. Erosion observed was located adjacent to the levee along portions of the golf course where landscaping lacked ground cover. The levee's concrete lining was slightly exposed at several locations near the top of levee, which is an asphalt walkway.

Station 2+73, original concrete levee lining exposed.

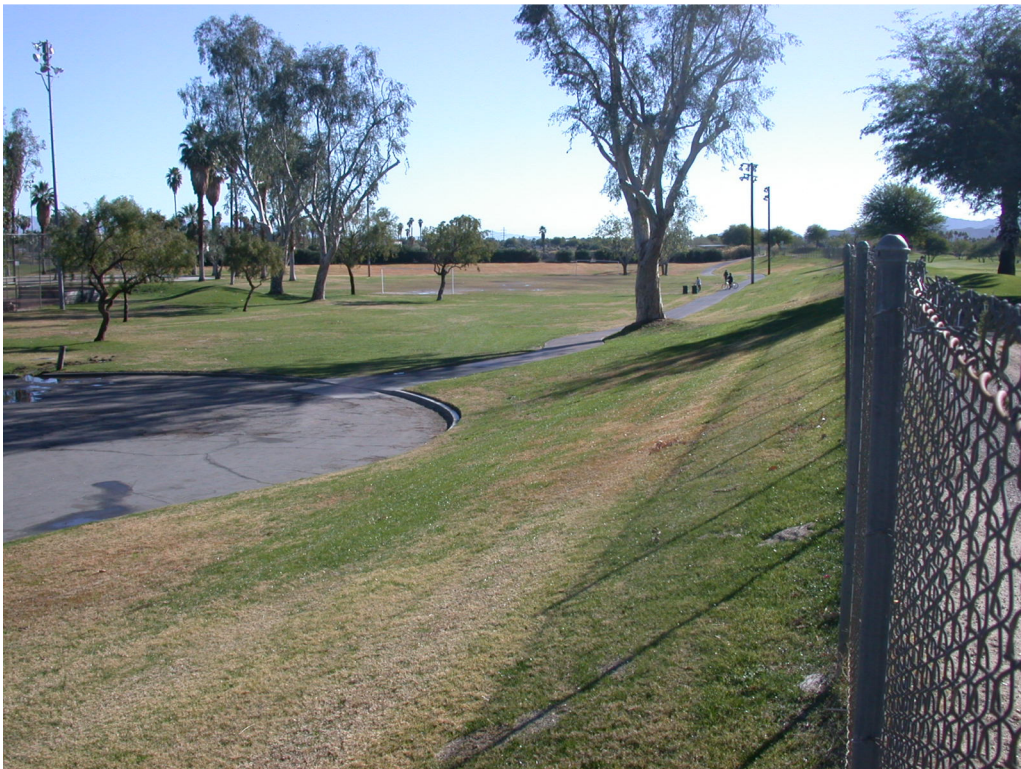
During the December site visit the Nolte Team observed a saturated low point on the landside of the levee at the Demuth Park soccer field. This low point is on the landside of the levee near the soccer field, adjacent to the Tahquitz Creek levee. This saturation could have been the result of a rain event that occurred prior to the site visit or to possible over watering of Demuth Park. After reviewing the Tahquitz Creek topographic data that was provided by the District, Nolte concluded ponding could occur at the soccer field after storm events because there are not any existing drainage facilities at this low point to alleviate ponding water.

Photo taken from top of levee at Station 7+83 looking at landside of levee. Ponding location at Demuth Park in the distance.

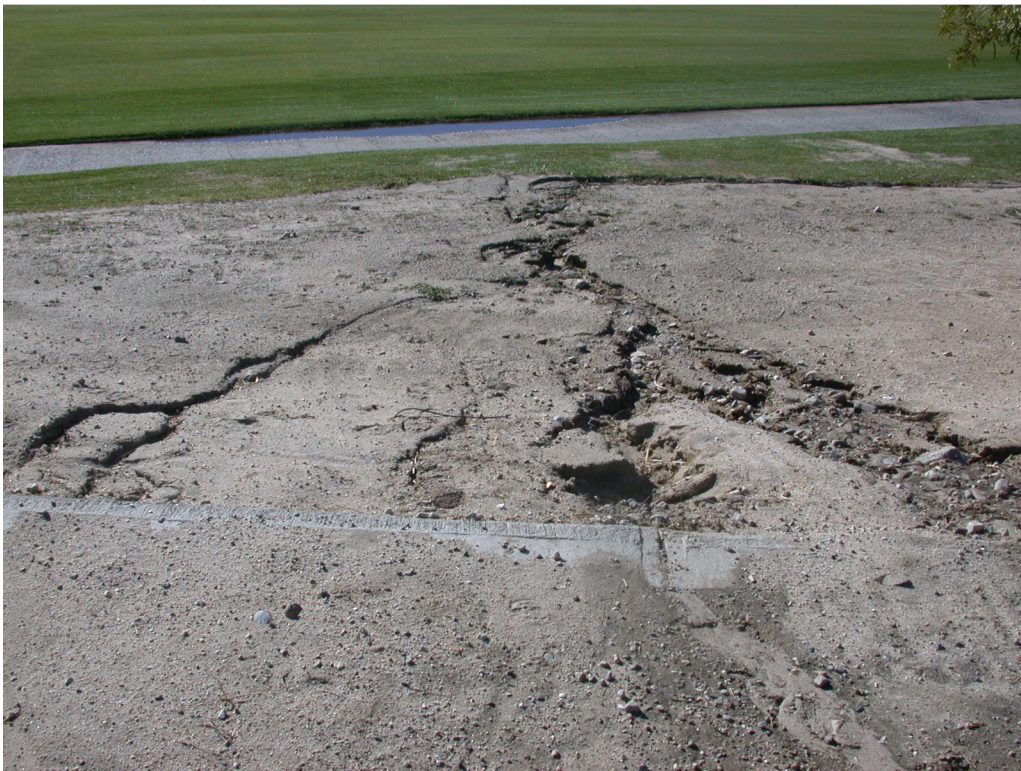
Station 25+97: erosion on channel slope of levee.

The primary concerns regarding the slopes are erosion, stability, and seepage. Eroded areas will be repaired. Erosion is generally the result of concentrating surface water flow at one location. In this case, measures such as adjusting grades along the levee crest can be taken to more evenly distribute the overland flow. After surface drainage has been improved, the eroded areas, if more than 6 inches deep, will be backfilled with compacted fill. Golf course turf covers the concrete slope protection in many areas of the north levee. In the event that the concrete slope protection is undermined, cracked or settled, the effective concrete slabs will be repaired or replaced. Sloughs, slides, or subsidence are indicative of instability and will be carefully evaluated and repaired immediately. Repair may consist of excavation, re-compaction, and installation of drainage measures. Specific repair measures will be developed by the O&M Superintendent or experienced civil or geotechnical engineer.

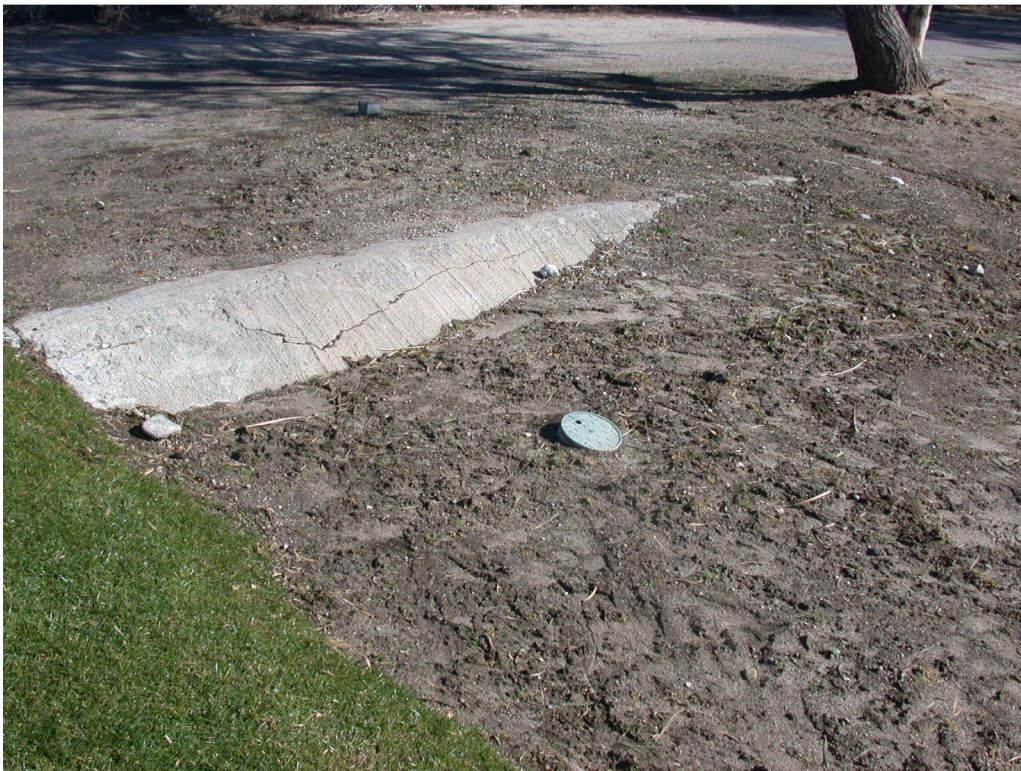
Station 36+83: original concrete levee lining exposed.

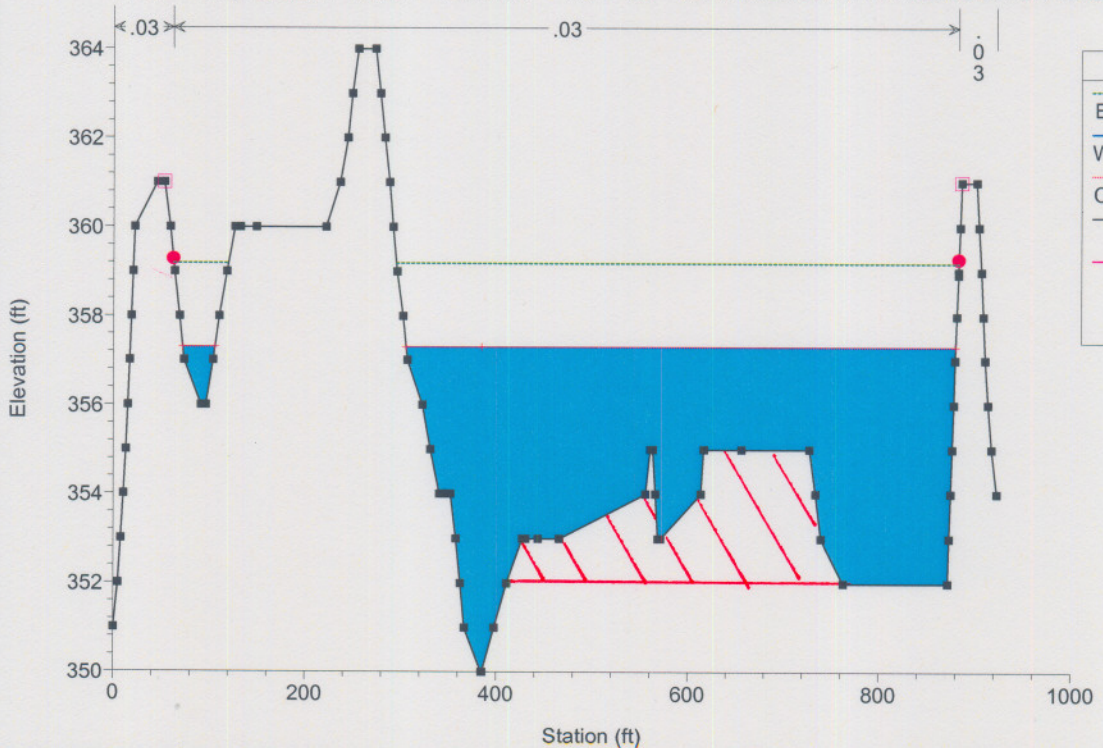
River = Tahquitz Creek Reach = Reach #1 RS = 120 CONFLUENCE WITH PALM CANYON WASH

The confluence of Tahquitz Creek with Palm Canyon Wash occurs at Cross Section 120 of Nolte's hydraulic model. The first solution evaluated to remediate Tahquitz Creek freeboard deficiencies was to lower the elevation of Palm Canyon Wash from approximately 75 feet upstream of Cross Section 130 to approximately 120 feet upstream of Cross Section 100. Grading Palm Canyon Wash to have a lower elevation at these cross sections will increase the conveyance and reduce backwater effects on Tahquitz Creek, providing adequate freeboard for Tahquitz Creek to meet the requirements of Section 65.10. The area of Palm Canyon Wash proposed to be graded are illustrated in a magenta boundary on existing Cross Sections 110, 120, and 130 of the Freeboard Deficiency Recommendation in Appendix D.

AREA TO BE REMOVED

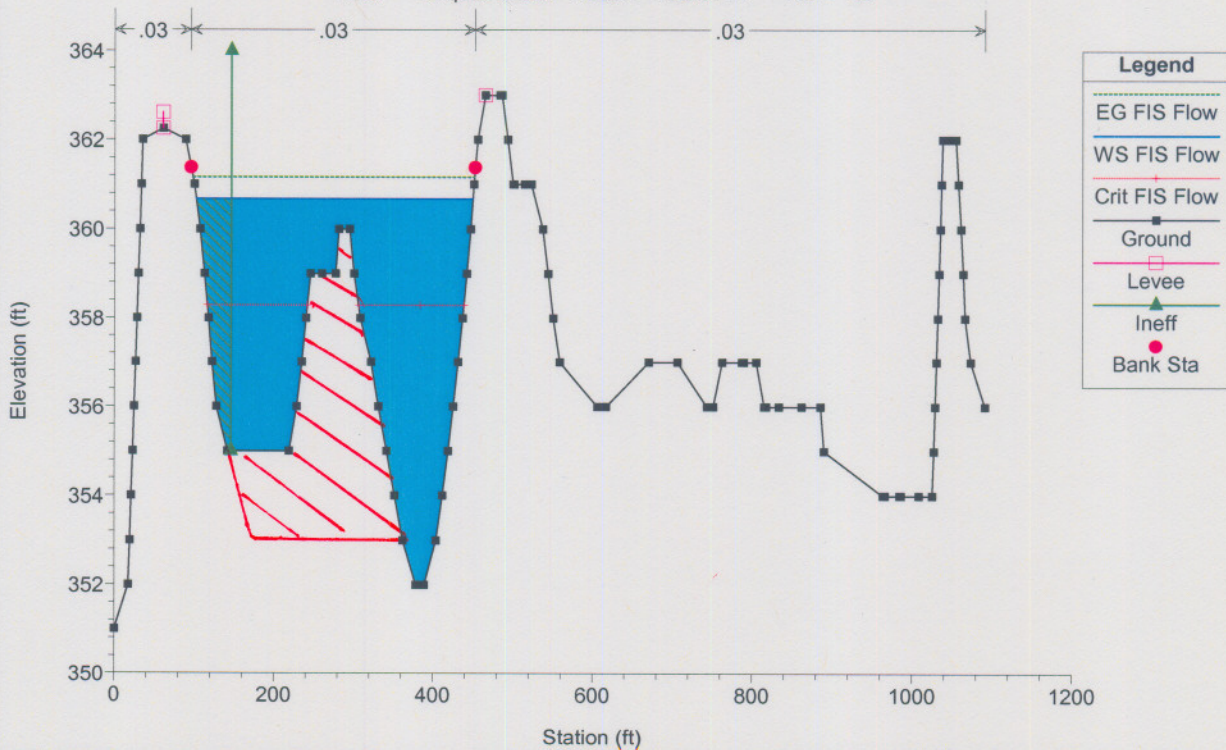
River = Tahquitz Creek Reach = Reach #1 RS = 130

The second option Nolte assessed to remediate Tahquitz Creek freeboard deficiencies is to propose grading within Tahquitz Creek. It is apparent that the several locations of the Tahquitz Creek Golf Course were constructed on fill, which reduced conveyance within Tahquitz Creek and is attributing to the levee not meeting the freeboard requirements of Section 65.10. Removing some of these high points (fill) at Cross Sections 120, 130, and 150 should resolve freeboard deficiencies. The high points that are proposed to be removed are illustrated in a blue boundary on existing Cross Sections 120, 130, and 150 of the Freeboard Deficiency Recommendation Exhibit in Appendix D. Cross sections showing these high points in the golf course that are proposed to be removed are located in Appendix F.

AREA TO BE REMOVED

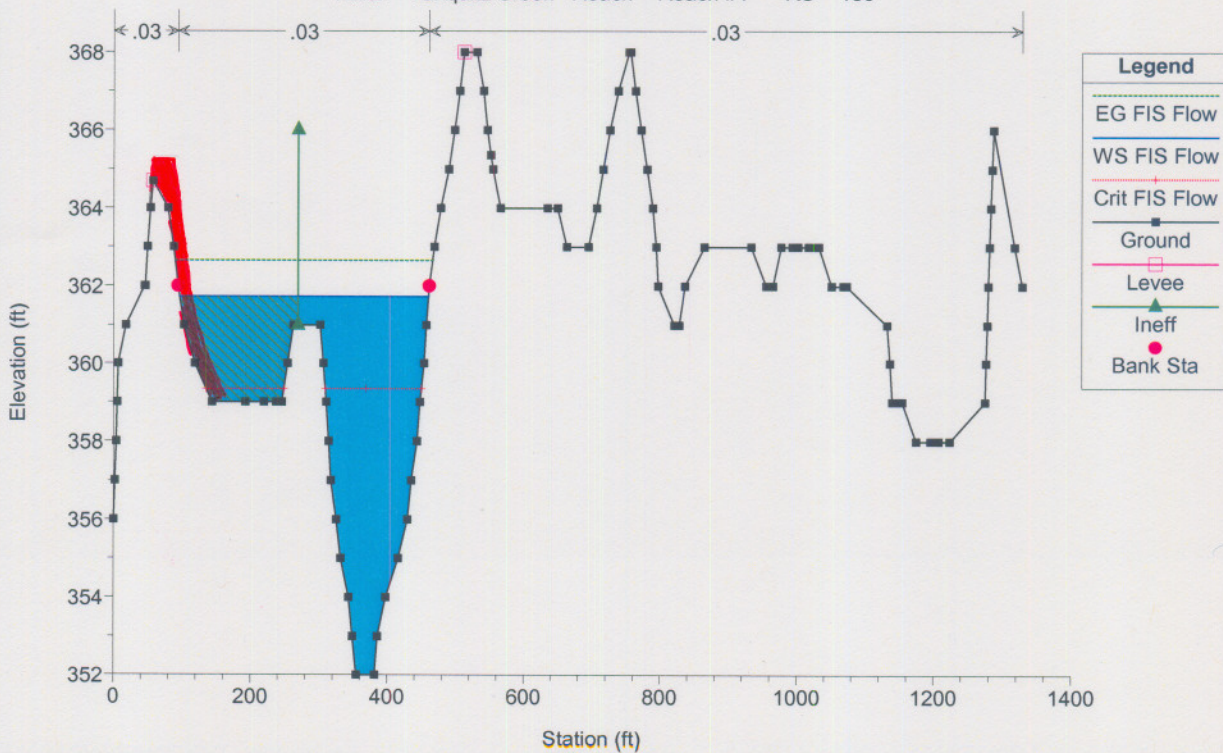
River = Tahquitz Creek Reach = Reach #1 RS = 150

Lastly, the third option Nolte evaluated to remediate Tahquitz Creek freeboard deficiencies was raising the elevation of the Tahquitz Creek levee by 0.5 feet to 2.0 feet for Cross Sections 130 through 160 (see Appendix D). Proposed Cross Sections 130 through 160 are included in Appendix G. Increasing the elevation of the levee at these cross sections will create grading within Tahquitz Creek that encroaches on the golf course, as can be seen on the Freeboard Deficiency Recommendation Exhibit. For proposed Cross Section’s 130 through 160, similar slopes of the levee (landside and channel side) were maintained for each respective cross section to preserve appearance of the golf course, which has gradual and rolling slopes. The levee slope (channel side) at several cross sections is particularly flat, at approximately 4 to 20 percent. The

APPROXIMATE CHANGE OF LEVEE TO INCREASE TOP OF LEVEE
